## **AVIATION INVESTIGATION REPORT**

**A03O0341**

### **LOSS OF CONTROL AFTER TAKE-OFF**

**de HAVILLAND DHC-3 (OTTER) C-GOFF**

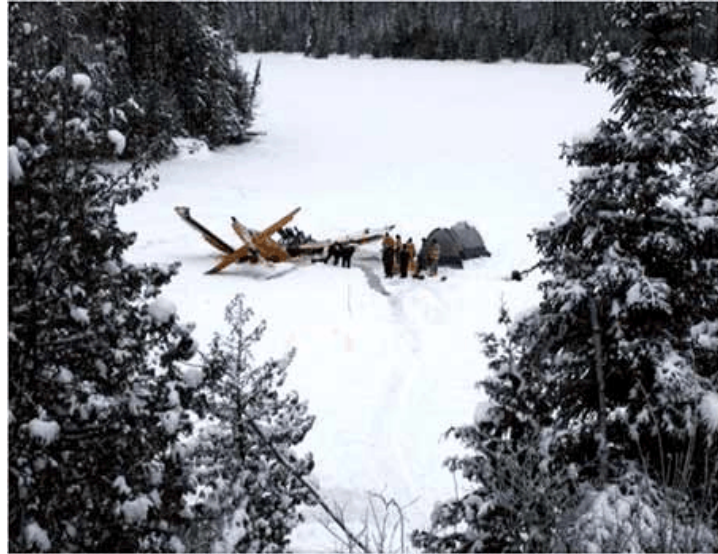
**Photo 1.** View looking downward from the end of the airstrip.

The airfield is located on private property, and the east/west airstrip is approximately 3400 feet long. Winter maintenance is limited to plowing a vehicle road that provides access to a maintenance hangar. Trees line the west and south sides of the airstrip, and at the east end of the runway there is a drop-off of approximately seventy feet to a lake. A metal tower, equipped with an anemometer, a windsock, and temperature and humidity transmitters is located at the midpoint of the airstrip on the north side.

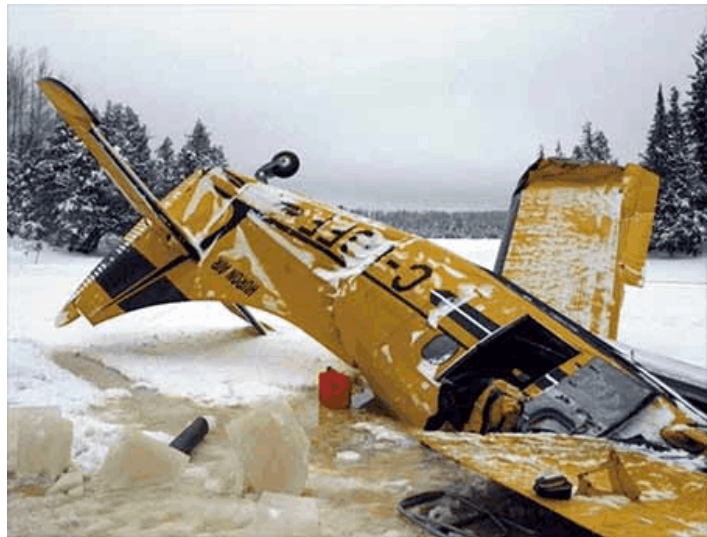
The aircraft wreckage was removed from the lake and examined. The cockpit compartment and most of the fuselage aft of the cockpit was substantially damaged. Both wings had separated from the fuselage at the wing-to-fuselage attachment points. The right wing had substantially more damage than the left as a result of absorbing the initial impact forces with the frozen surface. From the mid-point of the fuselage to the tail section the damage was minor. The propeller separated from the engine and a section of the gearbox remained attached. The extensive curling and torsional twisting of the propeller blades indicated that the engine was producing substantial power at impact. A flight control examination revealed no anomalies. The main landing gear was equipped with wheel/skis. The wreckage examination determined the two skis were down during the take-off. The track markings in the snow at the airstrip also indicated the skis were in the down position. Examination of the wheel/skis revealed no sign of contamination on the base of the skis.

**Photo 2.** Aircraft came to rest on the frozen lake surface.

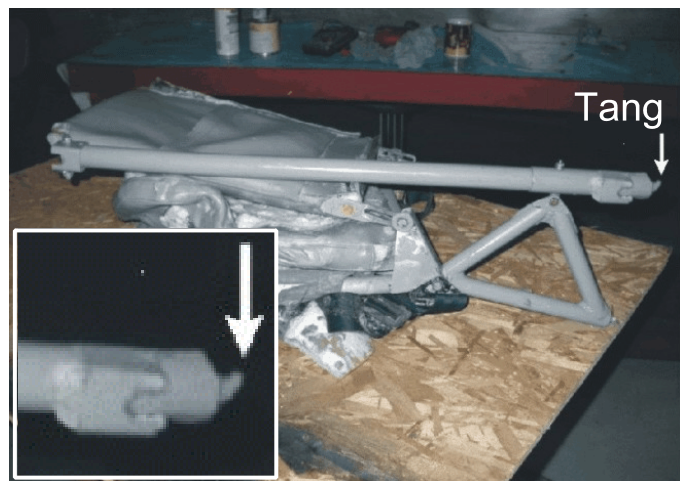
It was determined that the folding, cabin utility seat, occupied by the survivor, failed in overload. Further examination revealed that the tangs (Photo 3) at the bottom of the seat legs, which are inserted into the floor pick-up plate for seat security, were facing rearward. A de Havilland Alert Service Bulletin (A3/49 dated 19 July 1991) called for an inspection of the tangs to verify they are facing forward. In this occurrence the impact was of sufficient force that the seat would have failed even if the tangs had been installed correctly.

**Photo 3.** Survivor's seat — arrow points to the tang in the reversed position.

1. The validity of the aircraft's certificate of airworthiness was affected while it flew more flights than allowed by the ferry permit issued by Transport Canada.
2. The rear passenger seat was found to be installed incorrectly, contrary to de Havilland Alert Service Bulletin A3/49, dated 19 July 1991.
